MPAC128
MPAC128-ATEX
Acoustic imaging camera

What is acoustic imaging?

The Megger solution

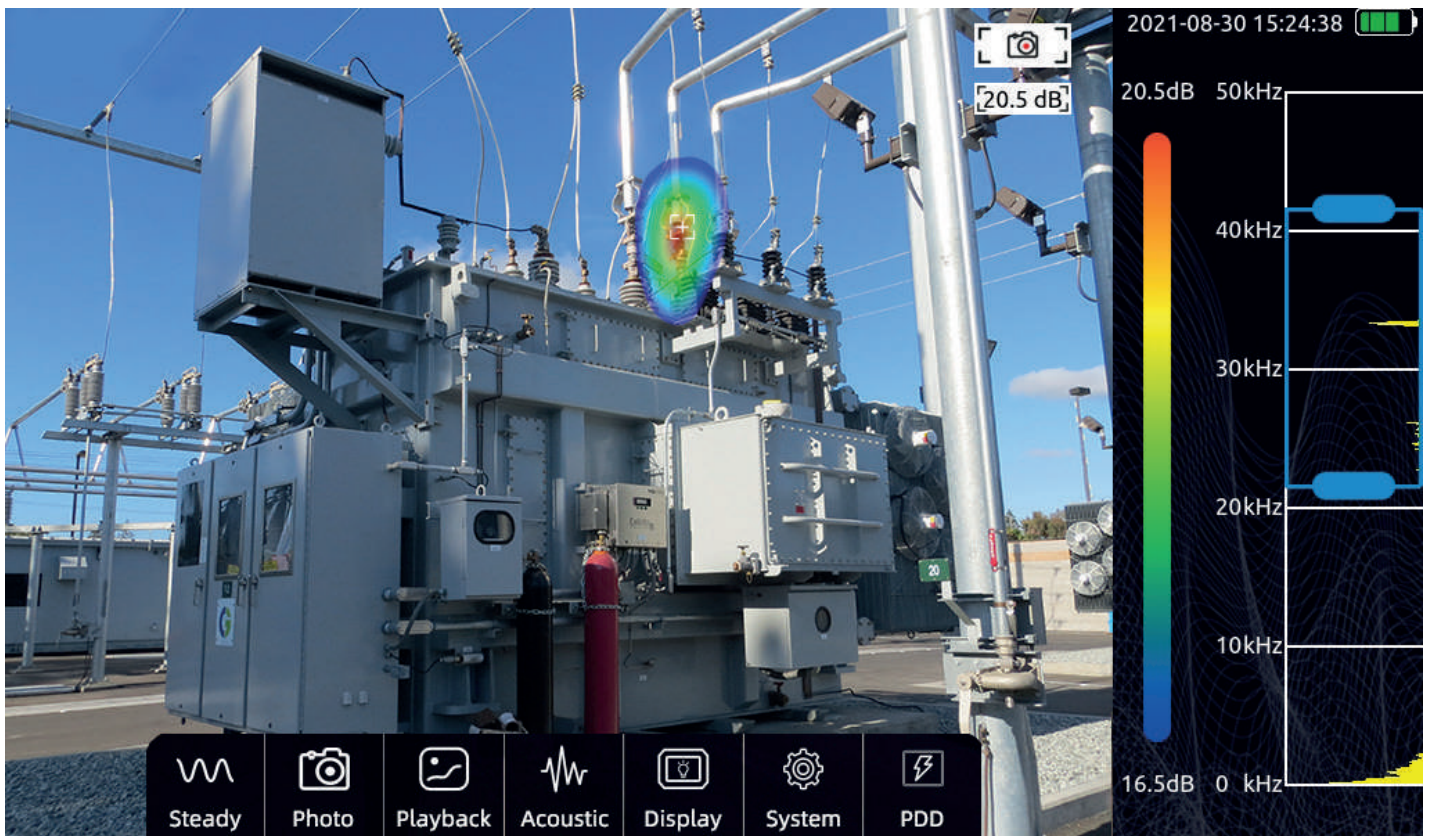
Many types of fault conditions, in particular, gas leaks and partial discharges, produce sounds. Sometimes, the sounds are audible, but more often, they are ultrasonic; that is, they are at frequencies above the limit of human hearing. By 'listening' for these sounds, it is possible, in principle, to discover that a fault is present and, by tracing the source of the sound, to find the location of the fault. This is the principle on which acoustic imagers work.

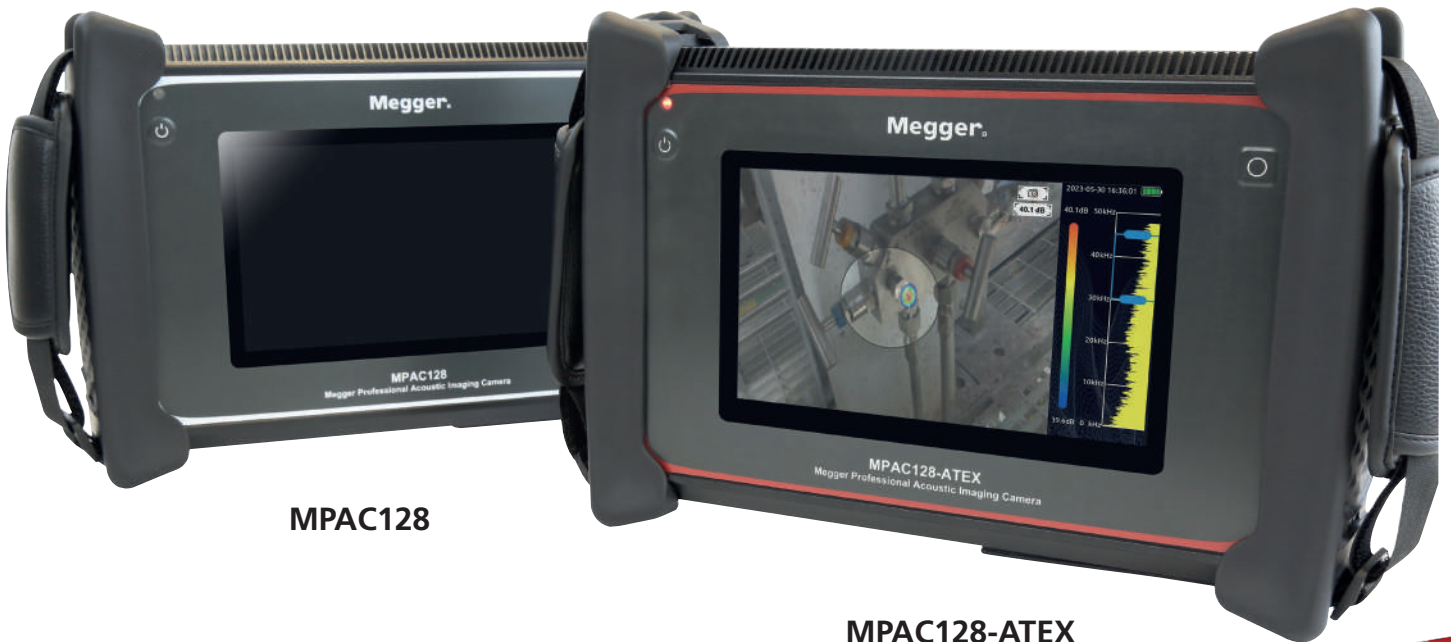
MPAC128

The Megger acoustic imager range consists of the **MPAC128** and the **MPAC128-ATEX** and are suitable for almost all PD applications and for many industrial applications, such as detecting compressed air leaks in non-hazardous areas.. The MPAC128-ATEX is ATEX-certified, so it can also be used in hazardous areas. In particular in the process industries, such as oil refineries and many types of chemical plant, the ATEX-certified version will be needed for use in areas where explosive vapours and gasses may be present. The MPAC128-ATEX is, of course, also suitable for use in non-hazardous areas.

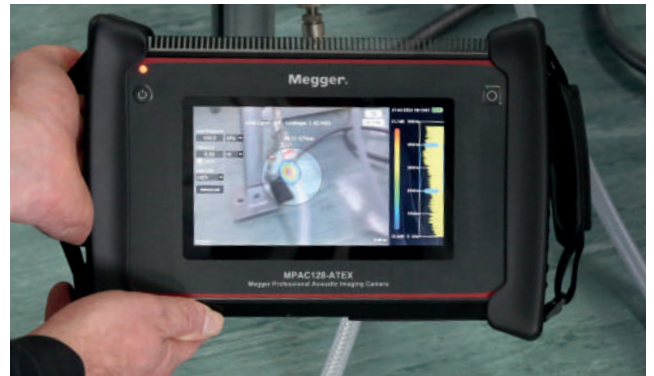
A key part of an acoustic imager is an array of microphones. The Megger acoustic imaging cameras have 128 microphones. The microphones pick up audible and ultrasonic sounds from a gas leak or partial discharge, using signal processing to suppress unwanted sounds so that the imager responds only to sounds from the fault.

An array of 128 microphones picks up audible and ultrasonic sounds from a PD event or a gas leak. By looking at the phase difference between the sound waves at each of the microphones, the instrument can determine the direction to the source and also the approximate size of the source.

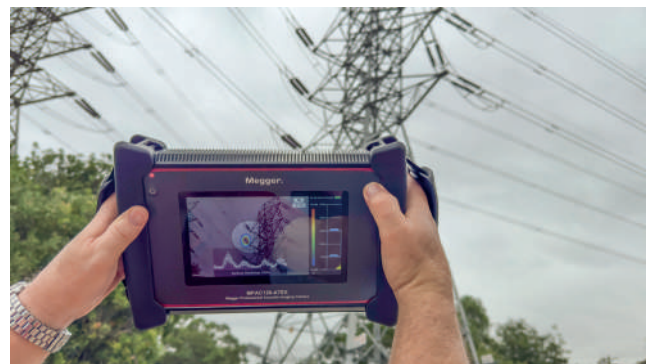
This method of detecting and locating faults has several advantages, the most important of which is that it involves no contact with the equipment or installation being examined. In fact, with the Megger equipment, faults can be detected at distances of up to 120 m.

This has important safety implications. When inspecting overhead power lines for possible PD, for example, there is no requirement for working at height and no need to approach energised conductors. Remote fault detection also saves time; a large section of plant can be surveyed for leaks in just a few minutes, whereas manual inspection to find leaks could take hours.

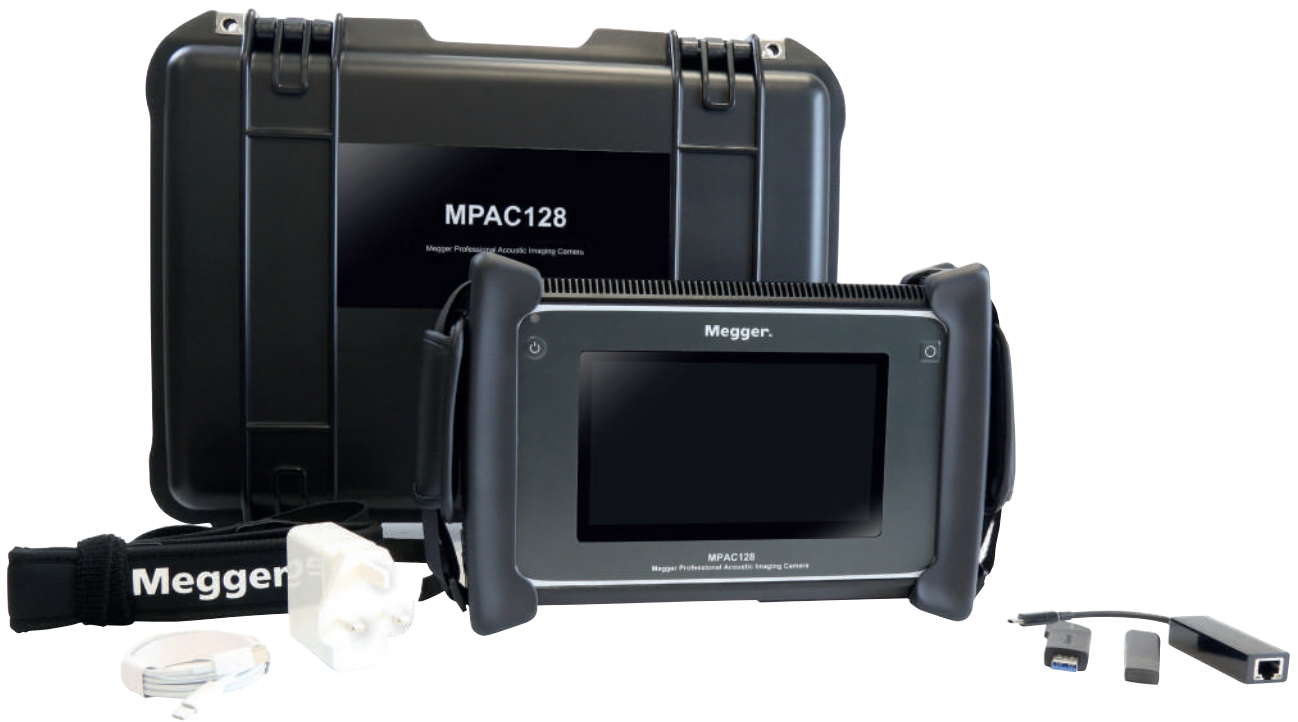
MPAC128 with carry case and accessories; carry strap, power plug and cable, Ethernet to USB-C adapter, 32GB USB memory stick, USB adapter for SD card and micro SD cards.
